SPECIAL REPORT

Moisture in the Roofs of Cold Storage Buildings

Wayne Tobiasson and Alan Greatorex

November 1998

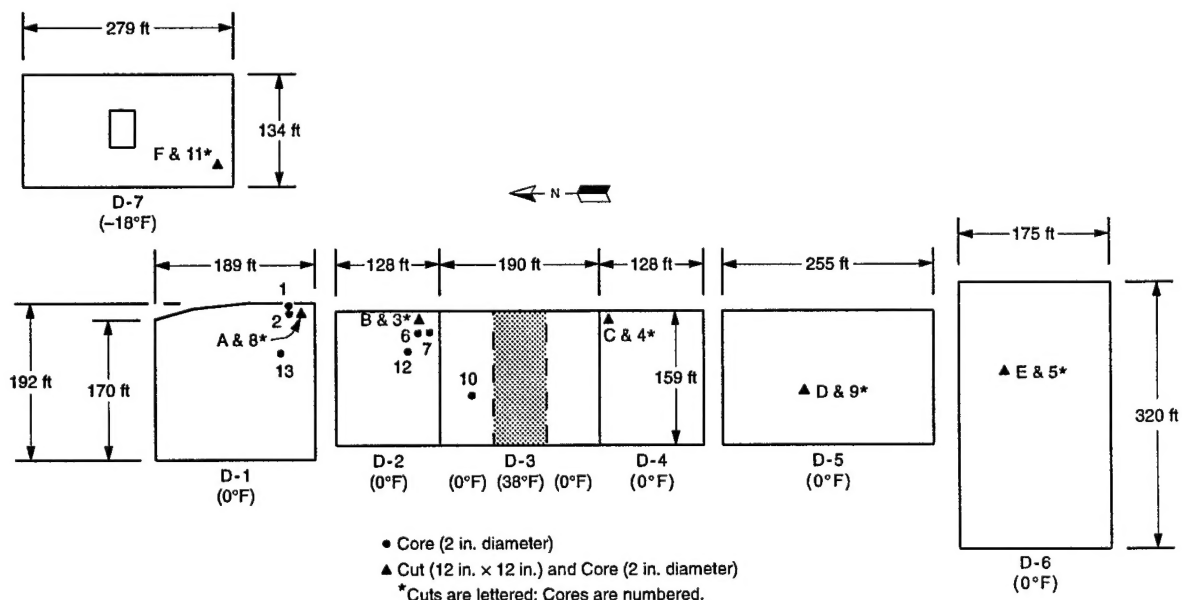
Figure 2. Plan view of the seven roofs examined in Dallas, Texas.

Bright areas were also detected by the infrared scanner in the southeast corner of this roof. Core samples 1, 2, and 8 and roof cut A were taken in this area (Fig. 2). Table 1 presents all core sample findings for this roof. The bottom 1 to 3 in. (2.5 to 7.6 cm) of fibrous glass insulation in this area was frozen "solid" (i.e., it was full of ice). Figure 8 shows the two areas of cleaned membrane where

cores 1 and 2 were subsequently taken. The individual is marking the area where core 8 and cut A were taken. Core 13, taken nearby where shown in Figure 2, was outside this bright (wet) area. All insulation was dry where core 13 was taken. Thus it appears that only a small area of wet (frozen) fibrous glass insulation is present in the southeast corner of this roof. No obvious flaw was uncovered that could be held responsible for this problem. It is likely that the flaw was in the old membrane, and the wetness has been present since the old bituminous built-up membrane was overlaid with additional insulation and a ballasted EPDM membrane. Because this moisture is located deep in the roof, not near its top, the thermal anomaly should have been dark not bright. Since it was bright, something else is happening here. One possibility is that moist, warm air is infiltrating into this portion of the roof below the old membrane.

Figure 2 shows where 12- × 12-in. roof cut A was made. Results of tests run on the components of that cut are presented in Table 2. Core 8 was taken at the same place as cut A. Both found the expanded polystyrene insulation and the upper layer of fibrous glass insulation to be dry. However, the lower layer of fibrous glass obtained in cut A contained considerably more moisture than the similar layer in core 8 (14.8% vs. 1% by weight). In all likelihood, some of the wet fibrous glass below was collected in the cut while it was all left behind in the core. Prior CRREL studies (Tobiasson et al. 1991) indicate that fibrous glass with a moisture content of 14.8% by weight would have about 93% of its dry insulating ability (i.e., it would have a Thermal Resistance Ratio [TRR] of 93%). However, the TRR obtained by measuring the insulating ability of these fibrous glass specimens before and after drying them was only 36%. Differing test

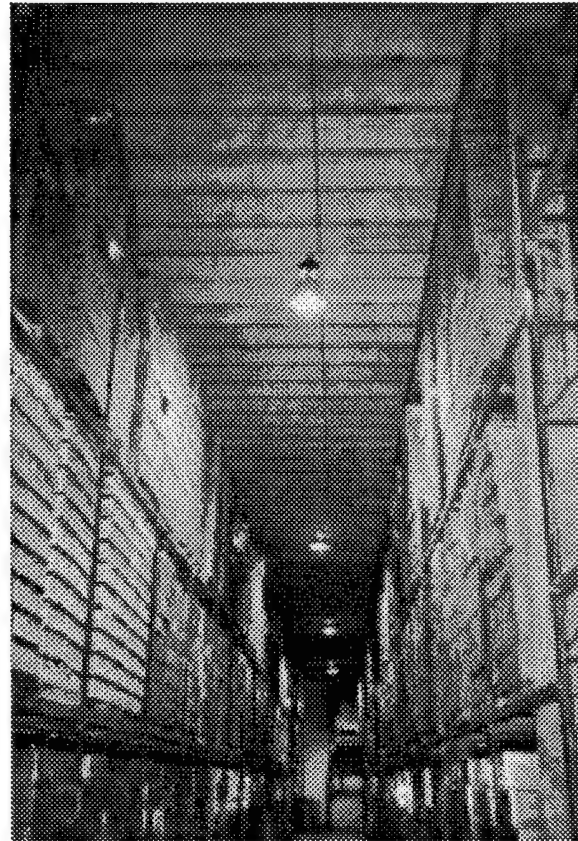
Infrared roof moisture surveys were also conducted from within this freezer. Figure 9 is a general view of the interior showing the deck of precast concrete double-tee beams. Figure 10 presents

Figure 9. Interior view of the freezer below roof D1, which has a precast concrete deck.

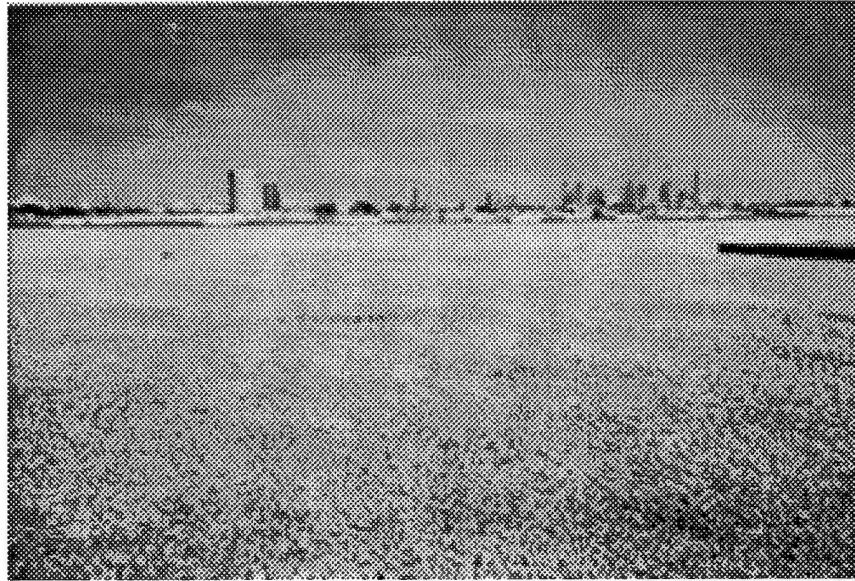
Figure 17. General view of roof D4 looking towards downtown Dallas (i.e., about southeast).

This roof consists of a ballasted EPDM membrane, expanded polystyrene insulation (2 in.), an old bituminous built-up membrane, fibrous glass insulation (7 in.), and a concrete deck. The temperature of the freezer below this roof was 0°F. A general view of this roof is shown in Figure 17. There were no bright or dark thermal anomalies on it. However, the infrared survey done within the freezer revealed extra brightness within a few feet (about a meter) of the northeast corner of this roof. That brightness was similar to that shown for roof D1 in Figure 11. We expect that it was caused by air infiltration not wet insulation. Core 4 and cut C were taken in this area to verify our suspicions. Core 4 findings are presented in Table 6 and cut C findings in Table 7. At core 4, a thin

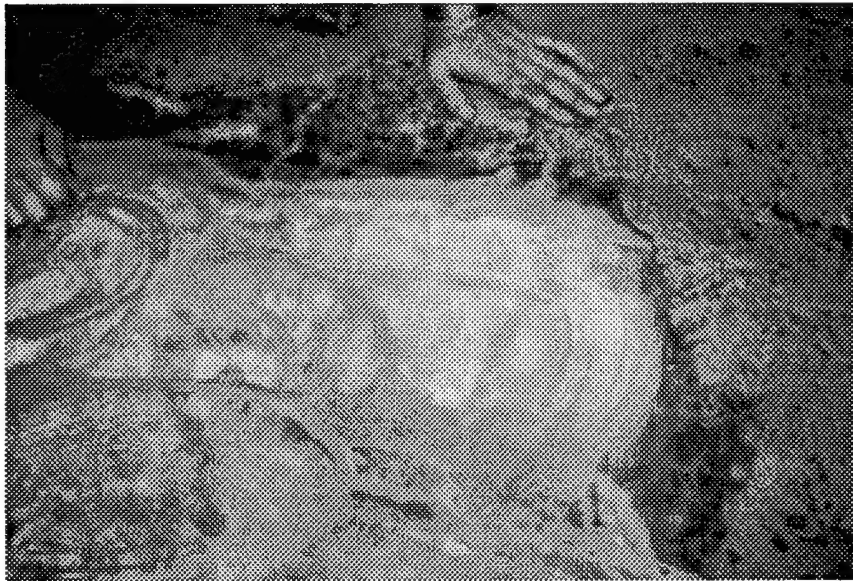
The Hypalon was not well installed and numerous wrinkles are present as shown in Figure 18. There is one bare spot on the roof where ballast does not protect the Hypalon. It is shown in Figure 19. The membrane is also wrinkled there. There were no bright or dark thermal anomalies on this roof. Core 9 and cut D were taken near the center of this roof where shown in Figure 2. Figure 20 shows the amount of dirt present on the Hypalon membrane. A considerable amount of effort was needed to clean the membrane so that it could be cut and patched properly. Figure 21 shows the cut made when taking cut D. That hole was backfilled

Figure 20. Cleaning the roof D5 Hypalon membrane before making cut D.

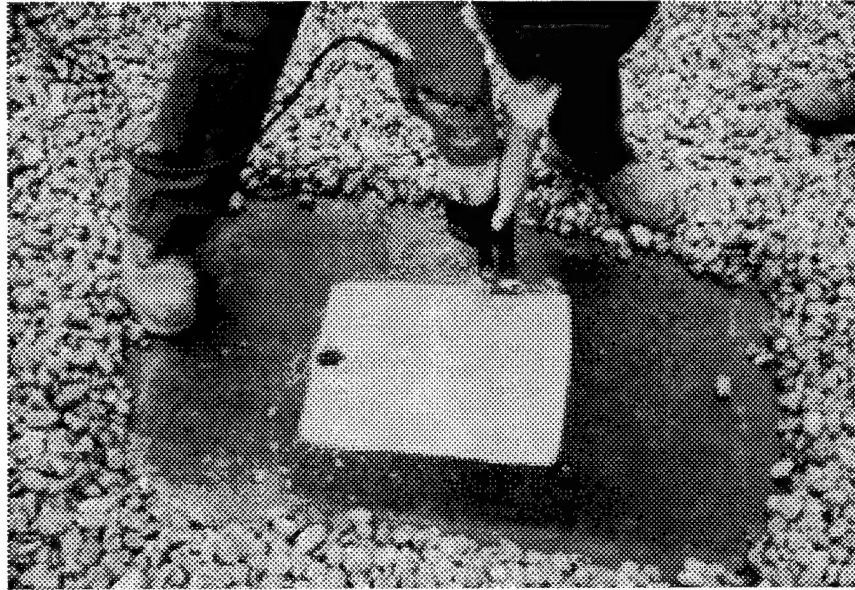
Figure 22. Hole where core 5 was taken and where cut E is being taken on roof D6.

No signs of entrapped moisture were detected during the infrared surveys of this roof. During the visual inspection, no membrane or flashing defects were noticed. Core 5 and cut E were taken where shown in Figure 2. Figure 22 shows cut E being taken where core 5 had been taken. Figure 23 shows the wall of the cut E hole. Table 10 presents findings for core 5 and Table 11 presents findings for cut E. All three types of insulation at this location were dry.

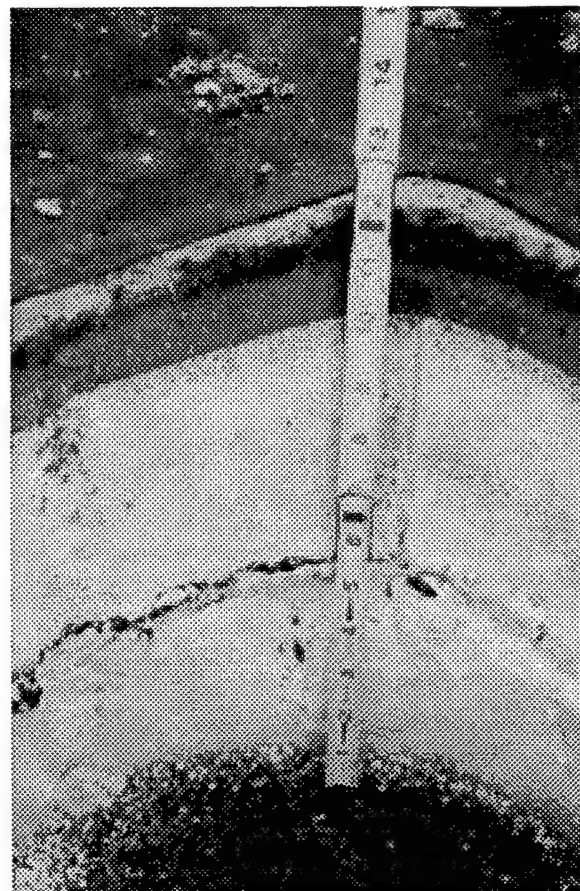
Figure 23. Cut E on roof D6 showing layers of wood fiber, perlite, and expanded polystyrene insulation.
